**Subject:** Rusting of Braking Surface

**Vehicles:** All Vehicles with Disc Brakes

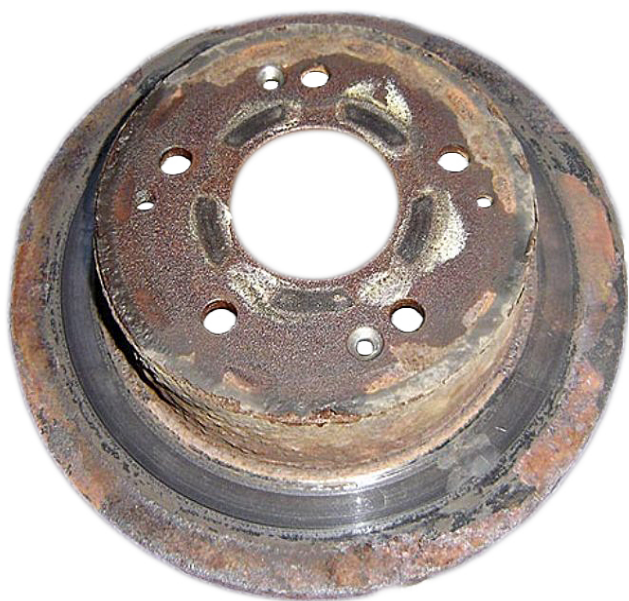
**Rust Flaking**

**Concern:** Rust on the braking surface of a rotor can be classified into 2 different categories: Rust Flaking (Left Image) and Rust Pitting (Right Image). It is important to understand the causes of the 2 different varieties of rust. Rust flaking is caused by a problem in the base brake system, not allowing the brake pads to fully contact the braking surface. Frozen or locked up caliper slides, a rusted caliper bracket or rusted anti-rattle clips will not allow the brake pads to slide freely. When the brake pads are not sliding freely, as much as 80% of the brake pad material may not make contact with the rotor. Rust then naturally appears in the metal but is never cleared away by the brake pads.

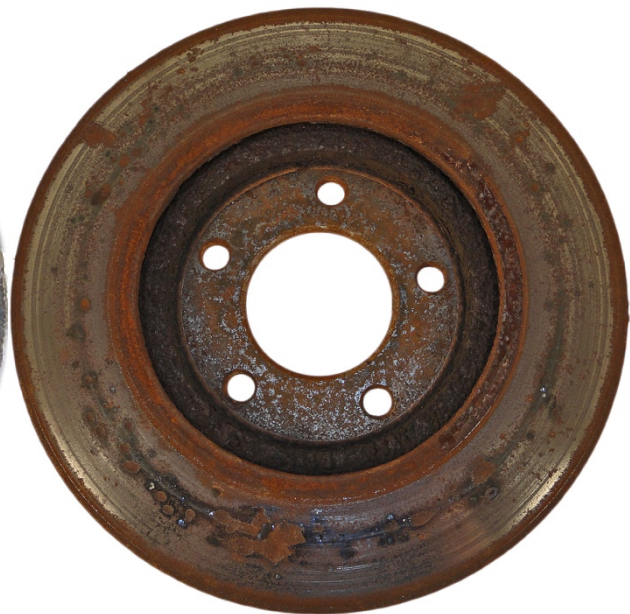
**Rust Pitting**

Rust pitting is caused by moisture in the brake pad material. The base brakes are working correctly, but due to moisture being held in contact with the rotor surface, small rust pits have formed. Under normal driving conditions the moisture and rust are cleared away. However, when a vehicle sits for extended periods or short trips are the norm, the moisture is never completely dissipated. The natural rusting process continues at an accelerated rate.
