Stop the ‘Warped’ Rotors Myth and Service Brakes the Right Way

by Chris Crowell - Dec 29, 2014

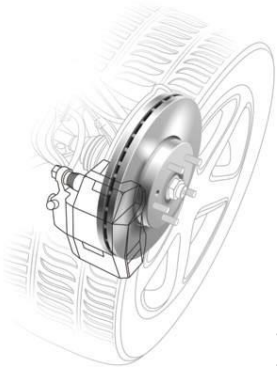
Lateral runout

Runout is a measurement of the difference between the high and low spots in the hub and on the rotor.

On each revolution of the wheel, as the high spot of the rotor scrapes unevenly with the hub or applies friction unevenly with the pad, the results for the rotor's face are just that — uneven.

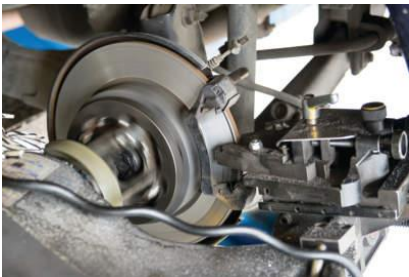
Cold brake roughness

Cold brake roughness manifests in a similar feel of pedal pulsation or steering wheel vibration, and in severe cases, there will be speed-related surges in deceleration felt during normal driving and light braking. This phenomenon is caused by lateral runout that exists when the rotors are initially mounted on the car. Over time, this gradually turns into disc thickness variation due to inconsistencies in the lining only touching the higher spots of the rotor during off-brake driving.
